Status of the MiniBooNE Horn

Ioanis Kourbanis

8/2/04

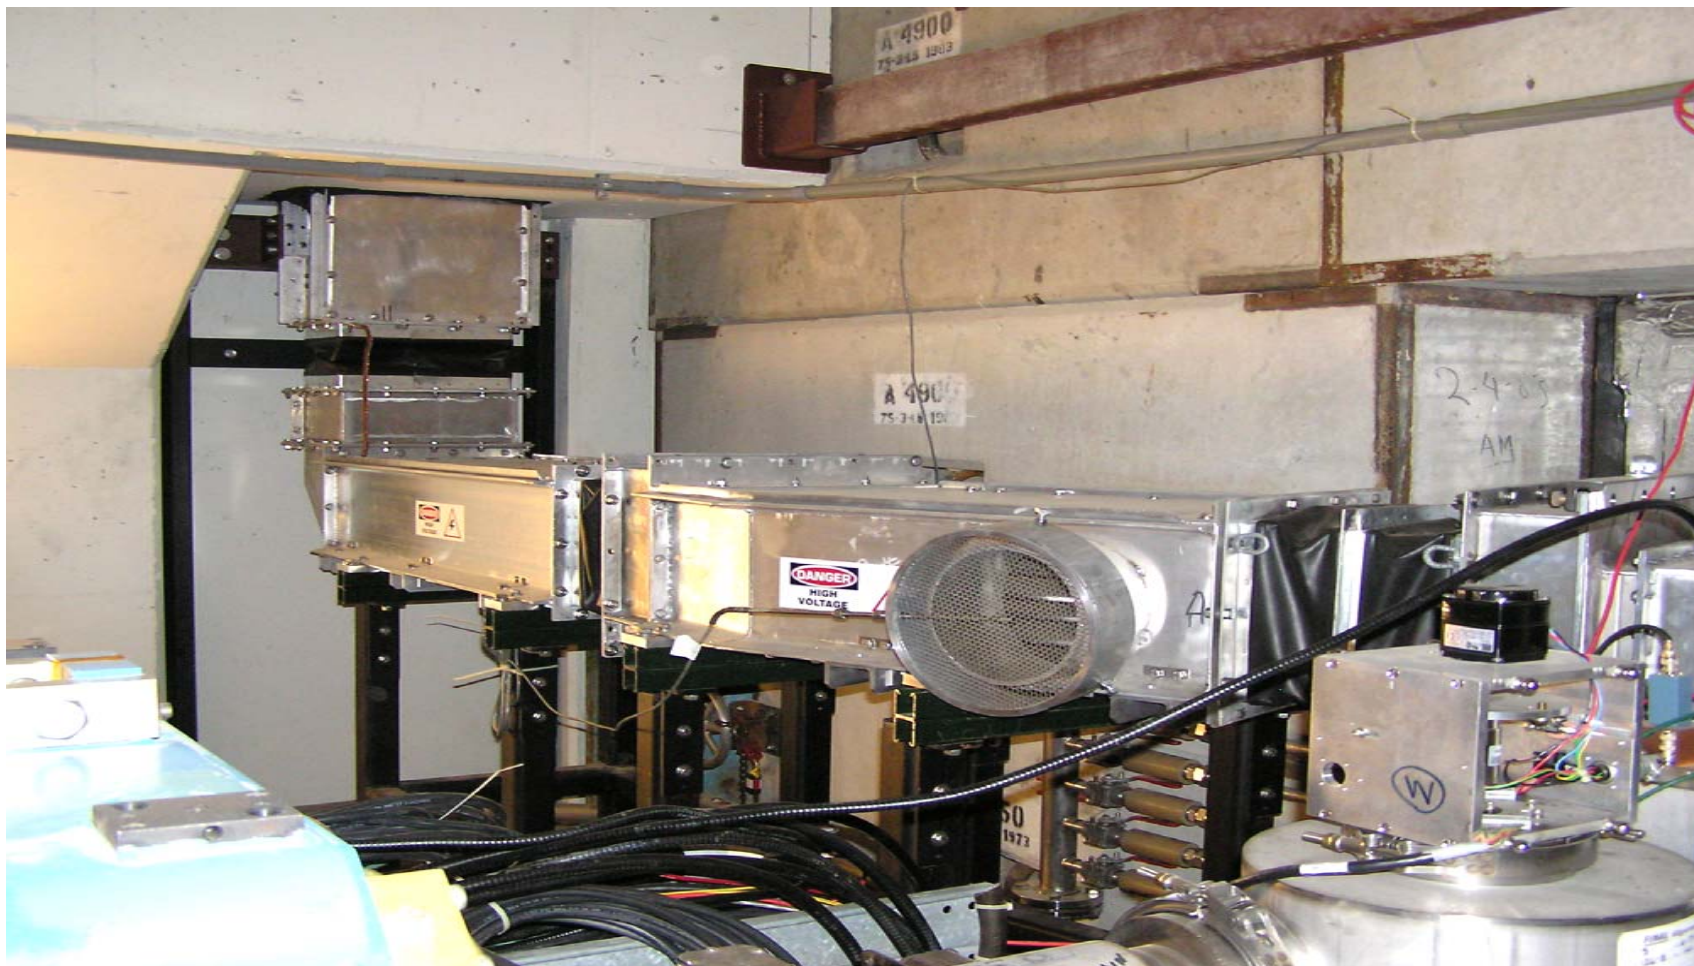
Stripline Connections to the Horn

- ❑ On Friday July 24 the Horn PS tripped on a Ground Fault indication.
- ❑ The trip limit was raised 25% and continued running till Sunday afternoon when we had another trip.
- ❑ After that we run the horn at a reduced current (mostly $\frac{2}{3}$ of the operational current) till Wednesday 07/28 when we shut down to diagnose the problem.
- ❑ On Wednesday we isolated the PS from the striplines/horn and determined that we had a ground fault with a DC Impedance of less than 1ohm.
- ❑ On Thursday 07/29 we isolated the striplines and determined that the short is in the horn box. We had no current run through the horn since then.

- ❖ Since the ground fault is in the horn box we have no way of fixing the problem and we will have to replace the horn.
- ❖ There is a way to reduce the actual ground fault currents and force most of the fault current to come back through the stripline cover plates to the PS allowing us to run a little longer. This plan has to be cleared with Electrical Safety first.
- ❖ There are a few things that we would like to do to diagnose the cause of the problem.
- ❖ Our spare horn and target will be ready in a couple of weeks.
- ❖ Many Thanks to the EE support for helping us diagnose the problem!

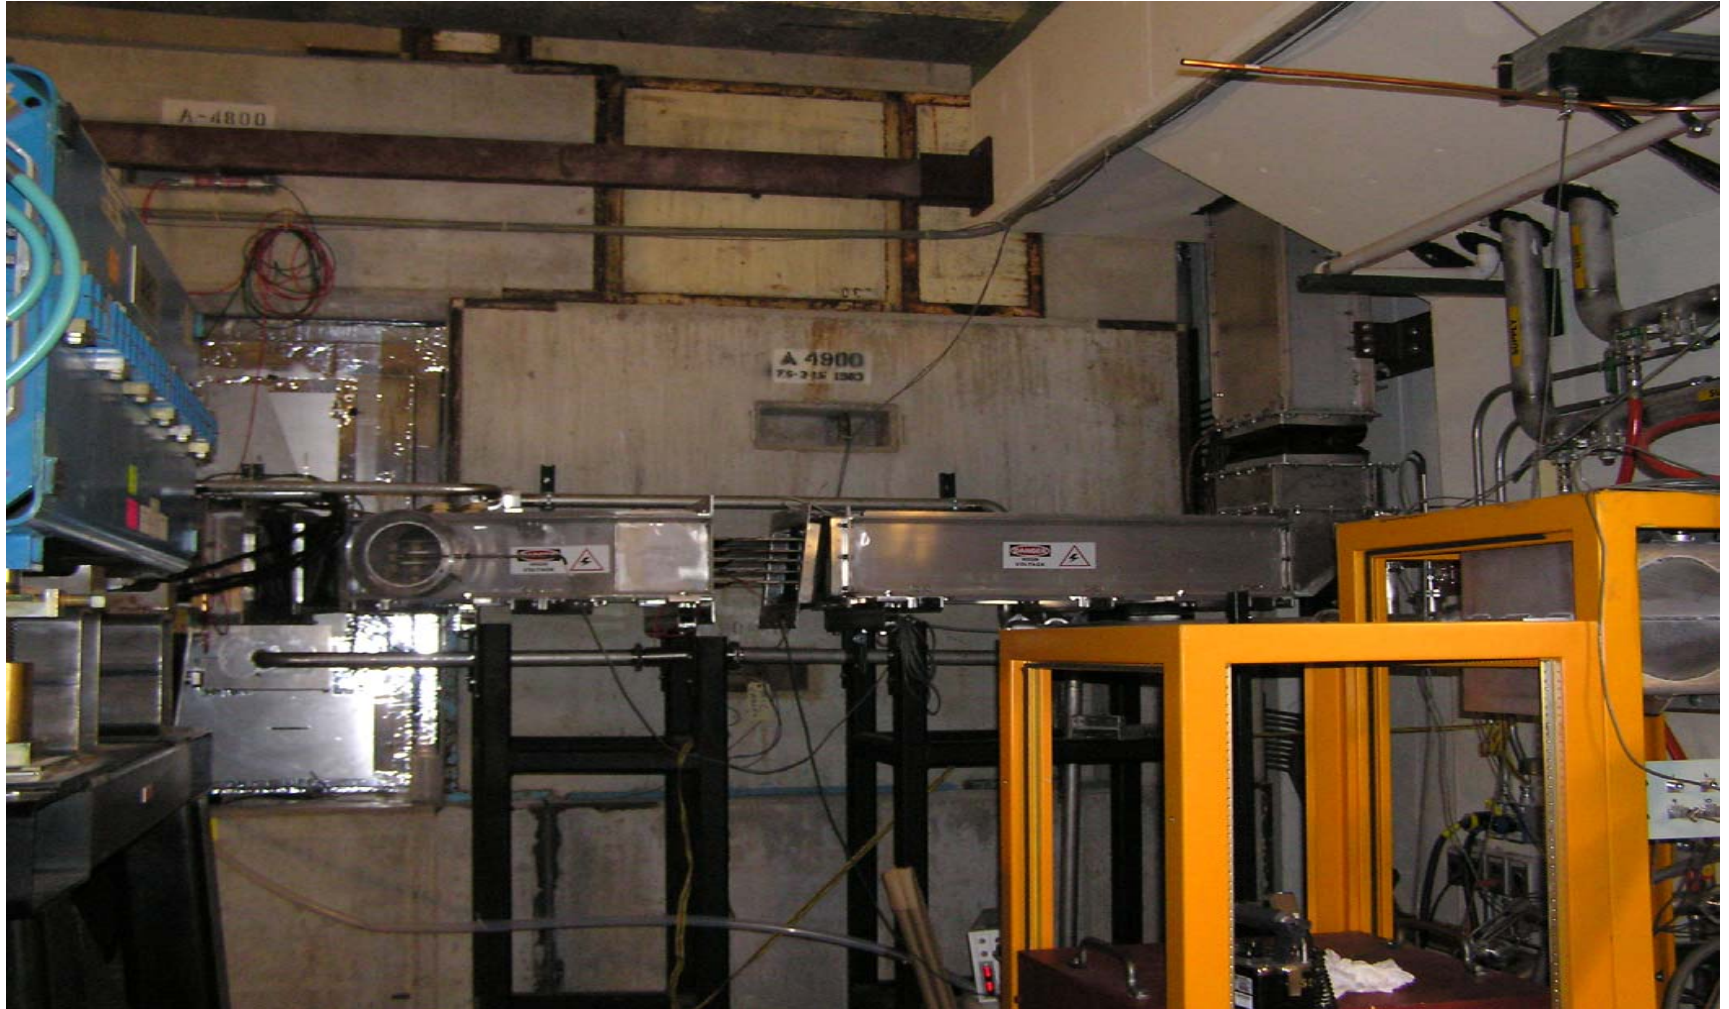
Disconnecting the stripline connections for the fault measurements
